QUY TRÌNH PHỦ CHỐNG ĂN MÒN DÙNG ACTION CLEAR

NEUTRAL SALT SPRAY TESTING REPORT

TEST REPORT

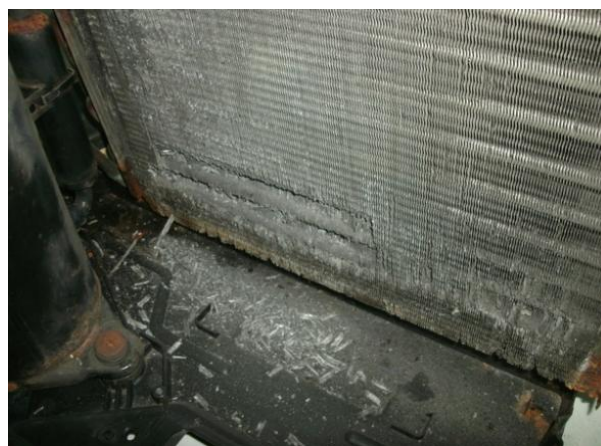
Hình: Dàn trao đổi nhiệt của máy lạnh bị ăn mòn do hóa chất và muối biển

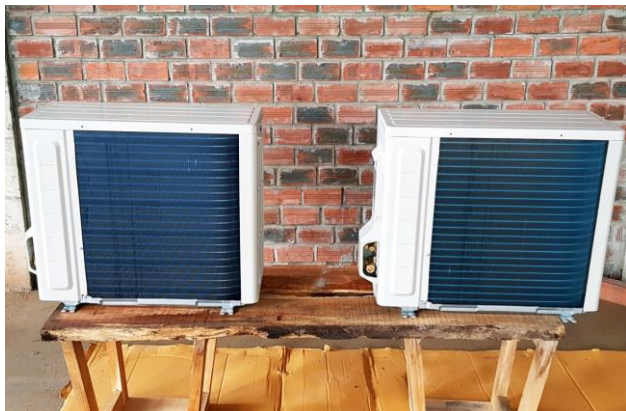
- Kiểm tra, vệ sinh kỹ bề mặt bên ngoài dàn nóng và coil dàn nóng

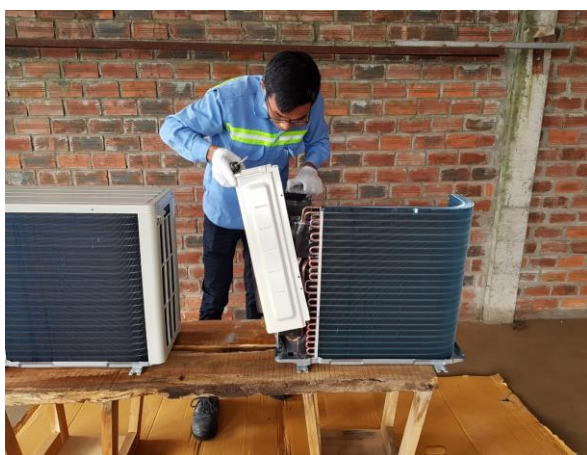
- Tháo các tấm che bên ngoài (lưu ý tránh làm trầy xước)

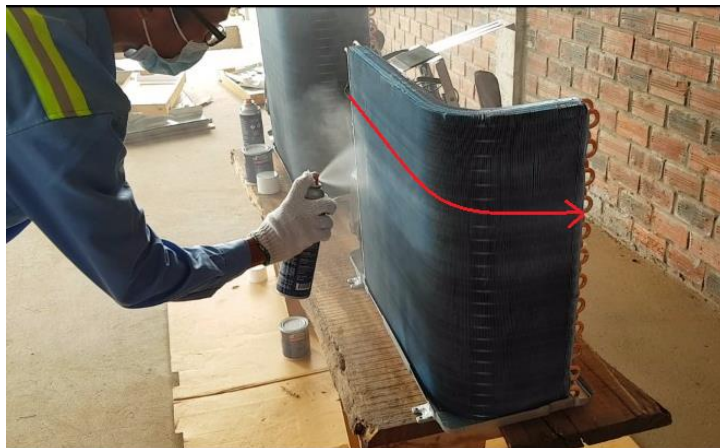
+ Bước 1: Phun sơn theo toàn bộ chiều ngang của dàn coil.

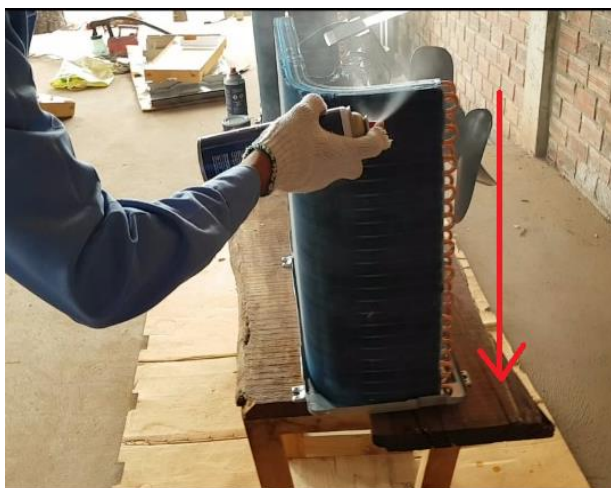
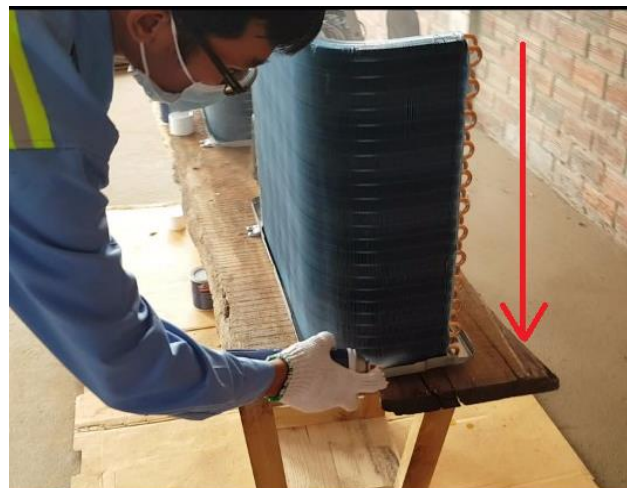
+ Bước 2: Phun sơn theo toàn bộ chiều dọc của dàn coil.

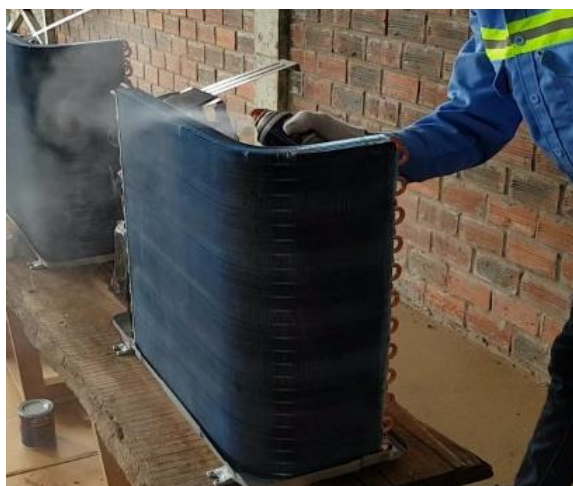
+ Bước 3: Thực hiện tương tự cho mặt đối diện của coil.

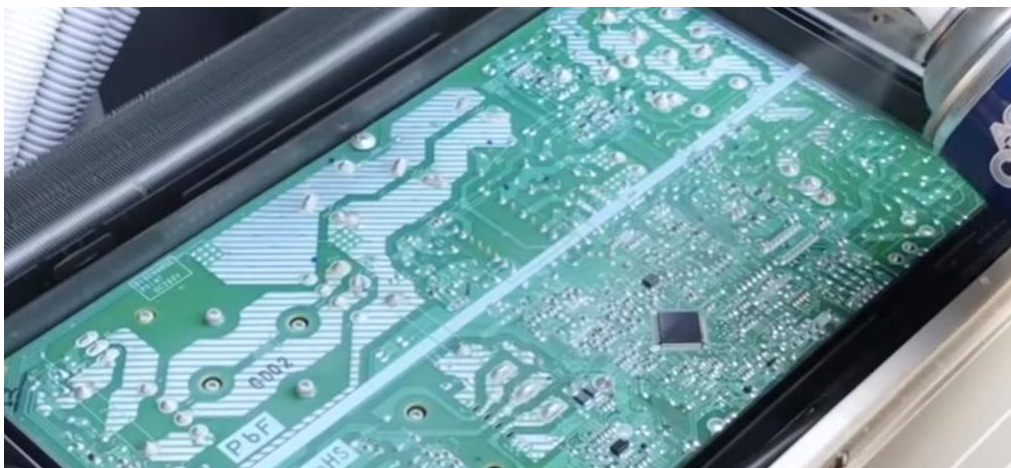
+ Bước 4: Sơn phủ lên board mạch của máy lạnh (trong trường hợp board của máy lạnh chưa được phủ lớp chống ăn mòn, phủ 2 lớp có thể làm ảnh hưởng hiệu suất và chức năng hoạt động do sự không tương thích giữa các thành phần của 2 lớp phủ)

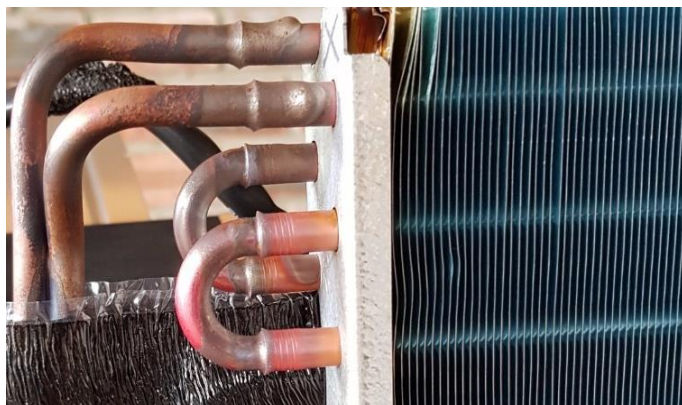
Trước khi sơn phủ

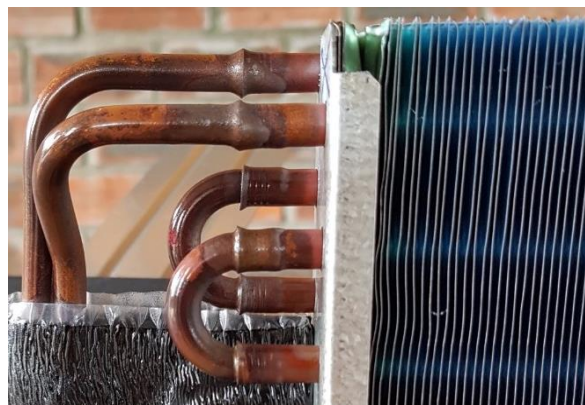
Sau khi sơn phủ

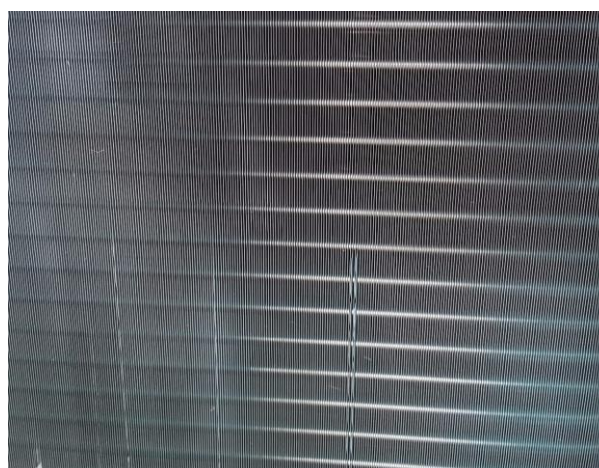
Sau khi sơn phủ

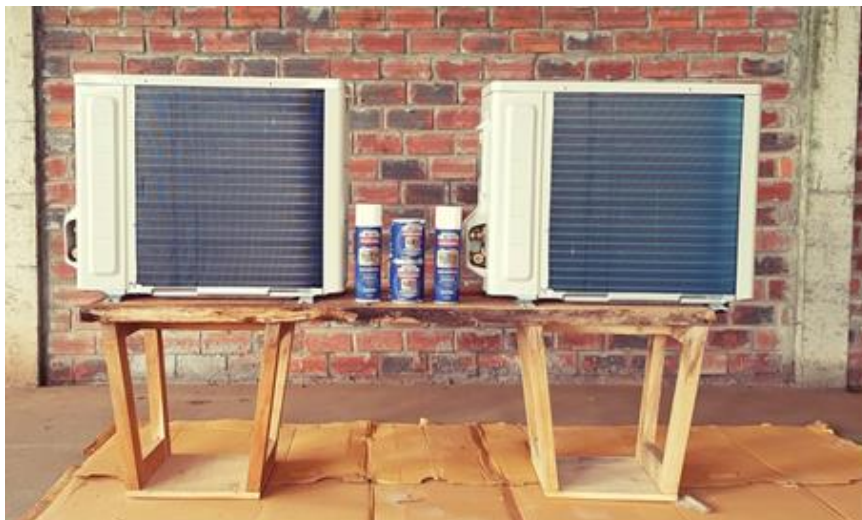
e. Thực hiện việc lắp ráp dàn nóng lại như cũ.

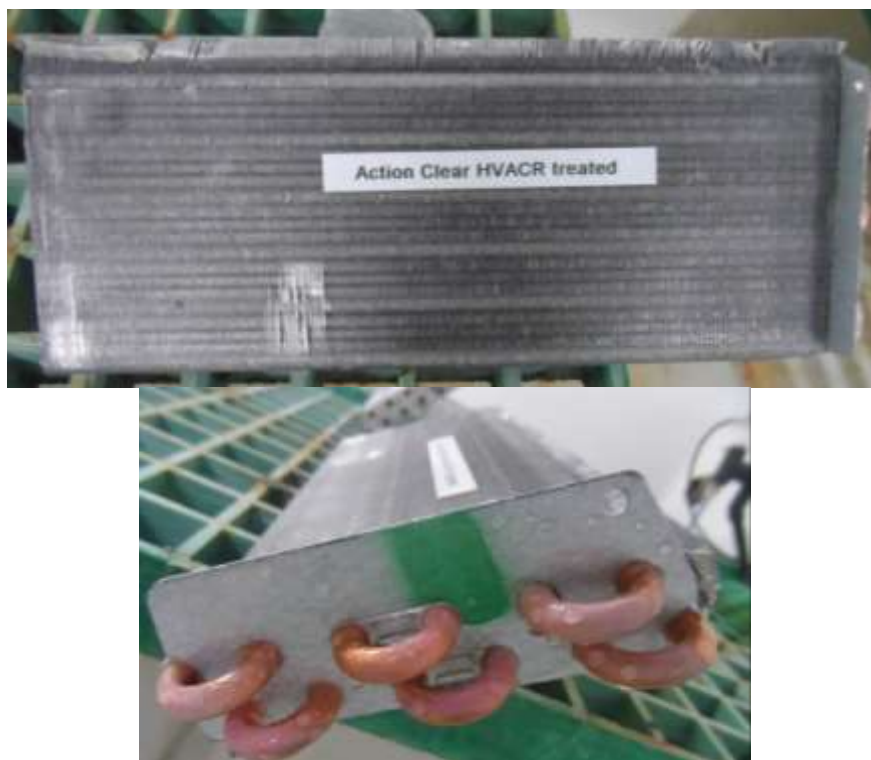
Fig 1: Action Clear HVACR Treated sample after 48 hours neutral salt spray exposure

Test No.	Sample ID	Duration (Hours)	Result
SS9517	Action Clear HVACR Treated	48	No significant change was noted
SS9518	Untreated Control	48	The sample end plates zinc coating is starting to be consumed showing ~10 % Coating loss
SS9517	Action Clear HVACR Treated	72	No significant change was noted
SS9518	Untreated Control	72	~60 % Coating loss on sample end plate & the formation of corrosion products was noted
SS9517	Action Clear HVACR Treated	168	Areas of very slight coating loss on the sample end plate ~5% The aluminium finned area is structurally sound and free of corrosion. No significant change in samples overall appearance.
SS9518	Untreated Control	168	~ 80% Coating loss & moderate amounts of red & white corrosion product noted on the sample's end plate The aluminium finned area is structurally sound, areas behind the end plate and close to edge have developed a build-up of white powdery corrosion products

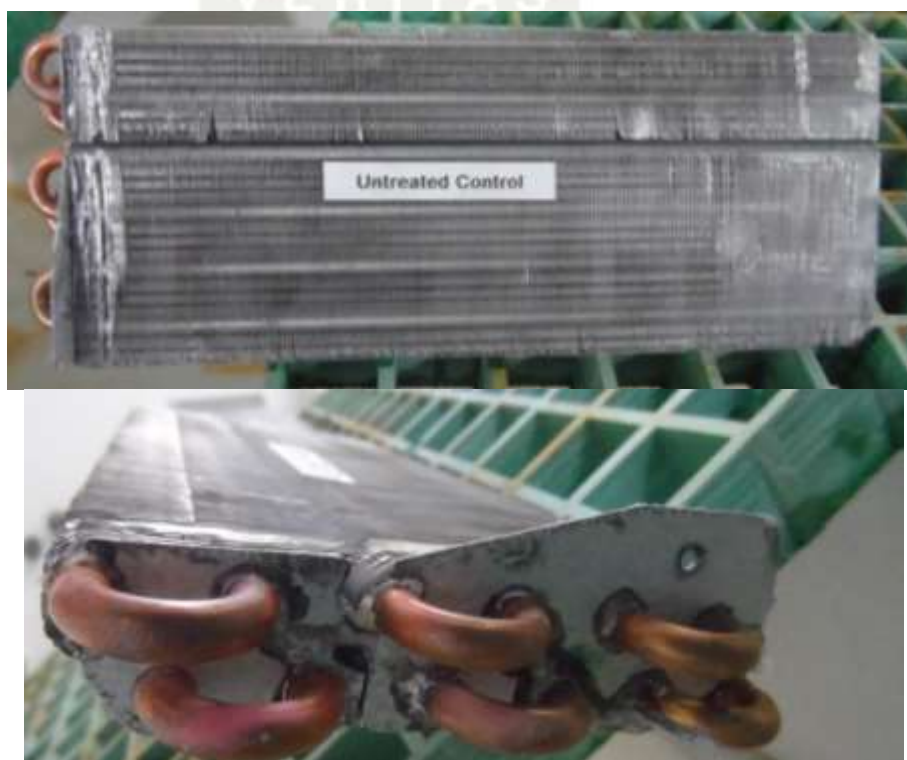
Fig 2: Untreated Control sample after 48 hours neutral salt spray exposure

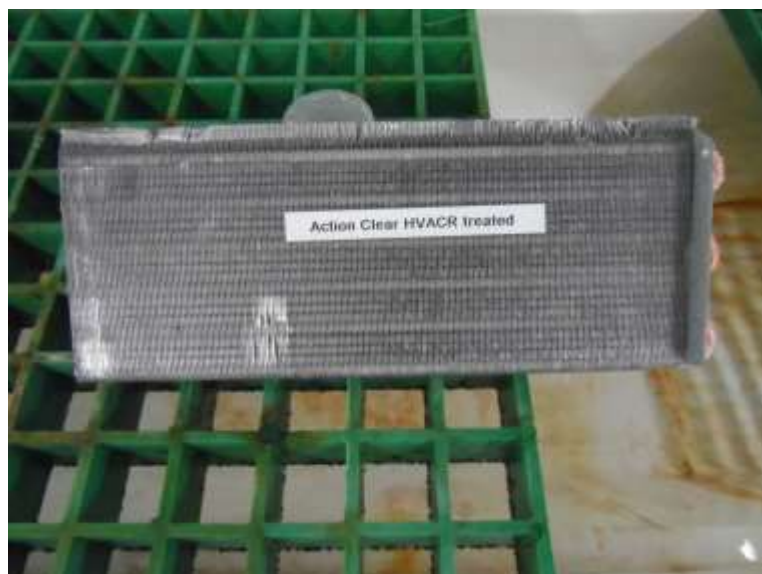
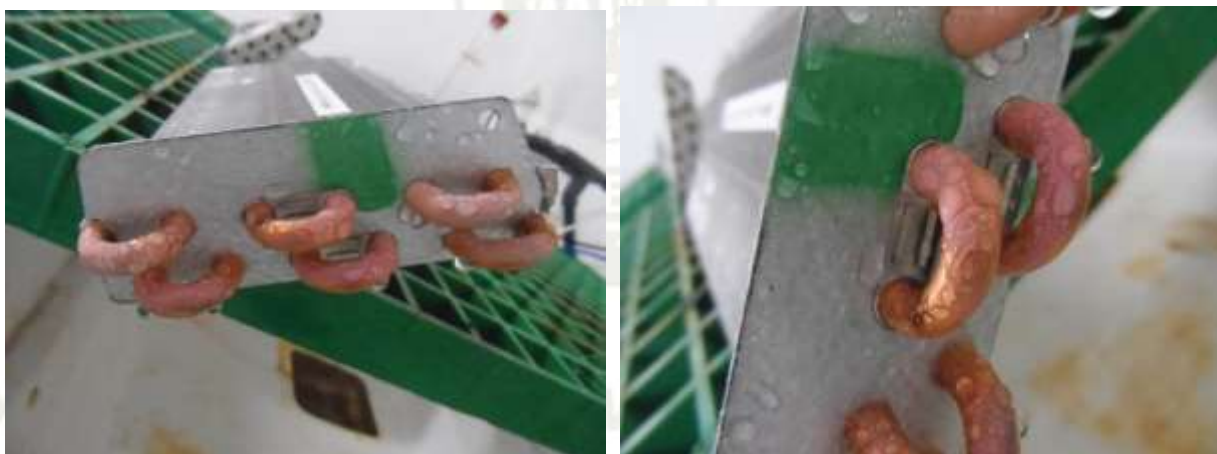
Fig 3: Action Clear HVACR Treated sample after 72 hours neutral salt spray exposure

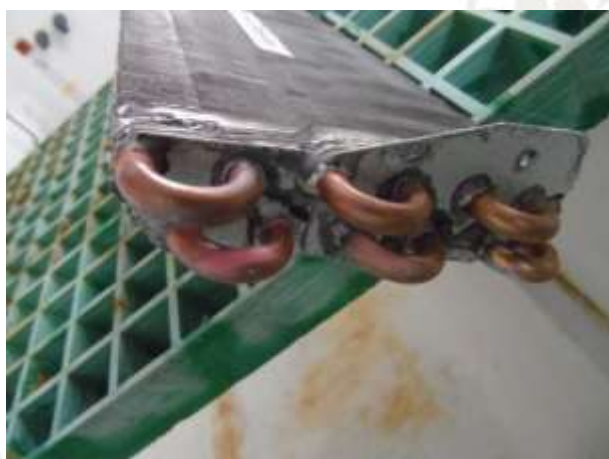
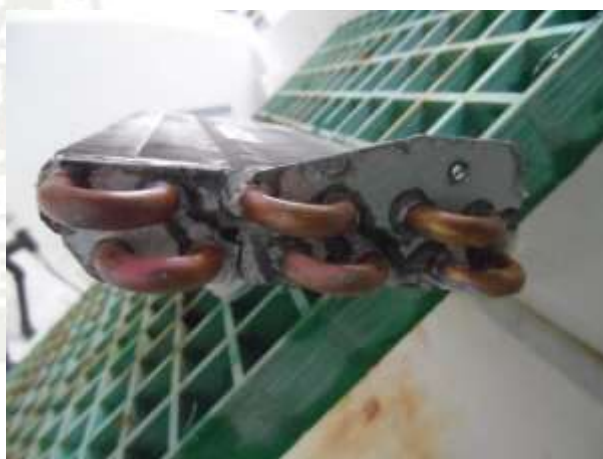
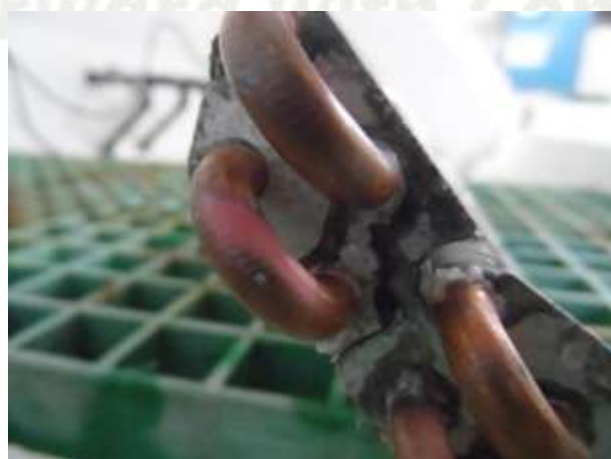
Fig 4: Untreated Control sample after 72 hours neutral salt spray exposure

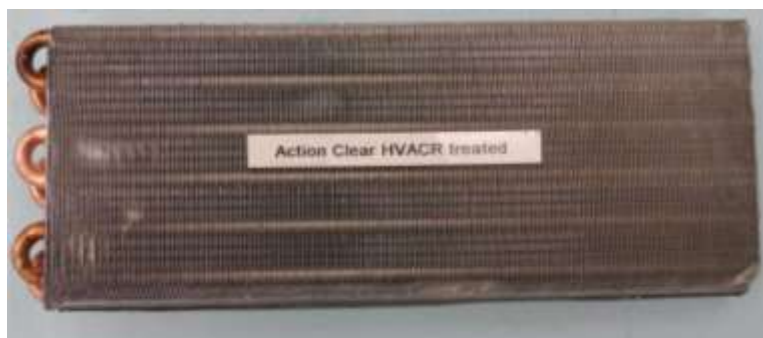
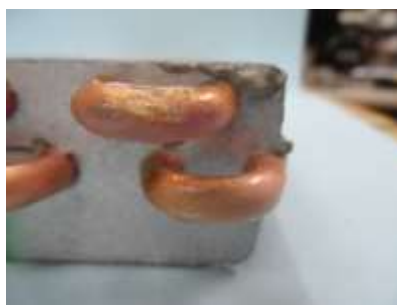
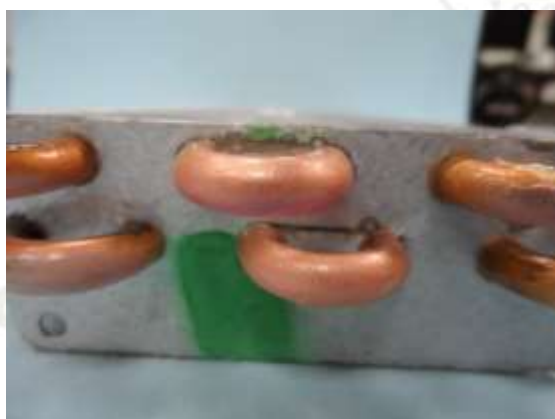
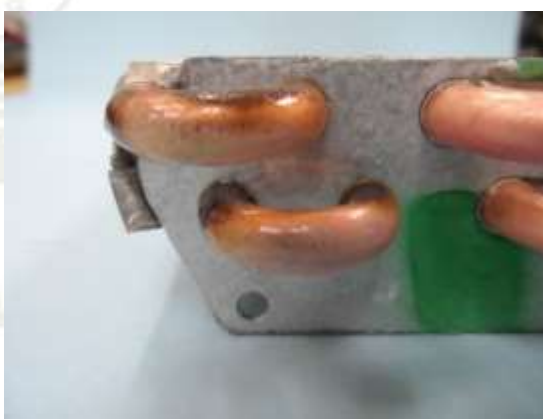
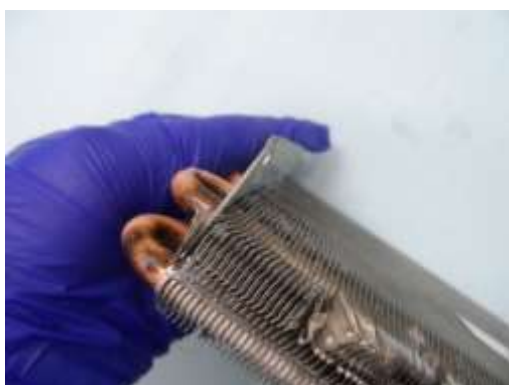
Fig 5: Action Clear HVACR Treated sample after 168 hours neutral salt spray exposure

In comparison, the sample coated with Action HVAC-R appears to be in sound condition with no such corrosion at the 48 hour and 72 hour mark and at the conclusion of the 168 hour test the testing authority has reported less than 5% coating loss.

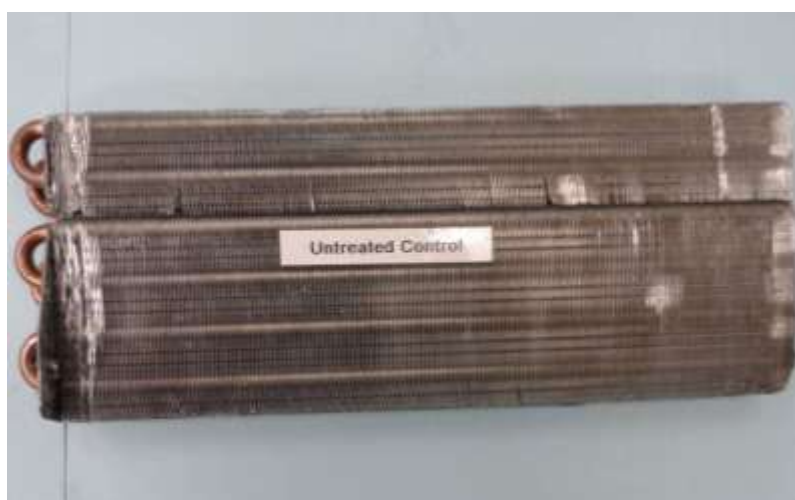
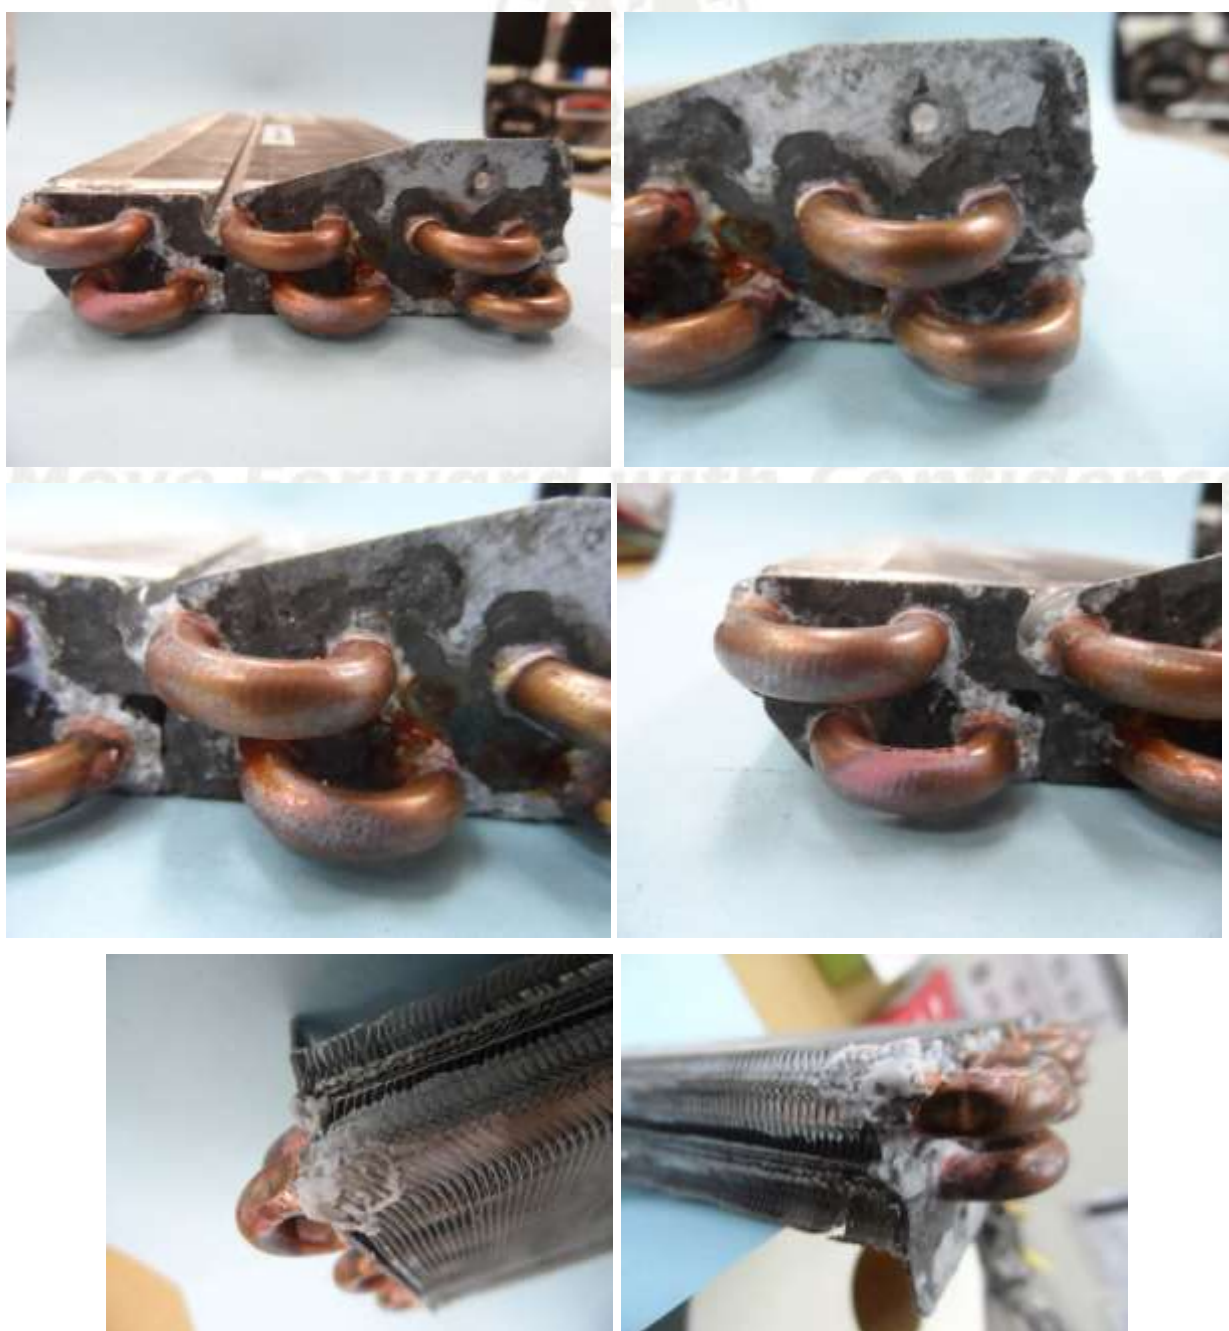
Fig 6: Untreated Control sample after 168 hours neutral salt spray exposure.

After viewing the content of the report and studying photos at the 48 hour, 72 hour and 168 hour mark CCE can state the untreated control sample appears to have been significantly affected by galvanic corrosion. The area of corrosion initiation would appear to be where the copper pipe contacts the galvanised carbon steel plate. (The Bureau Veritas assessed the coating loss to this area, after 168 hours, as being 80% loss of the zinc corrosion protection coating).

During exposure to corrosive atmosphere (neutral salt spray) the steel end plate's coating (zinc) tries to protect the iron in the plate and the copper in the coils by forming white corrosion products, the zinc layer is thin so if corrosion sets in the zinc protection is rapidly consumed, After becoming exposed the remaining iron in the end plate tries to protect itself and the copper coils from corrosion resulting in the formation of iron oxide (red rust).

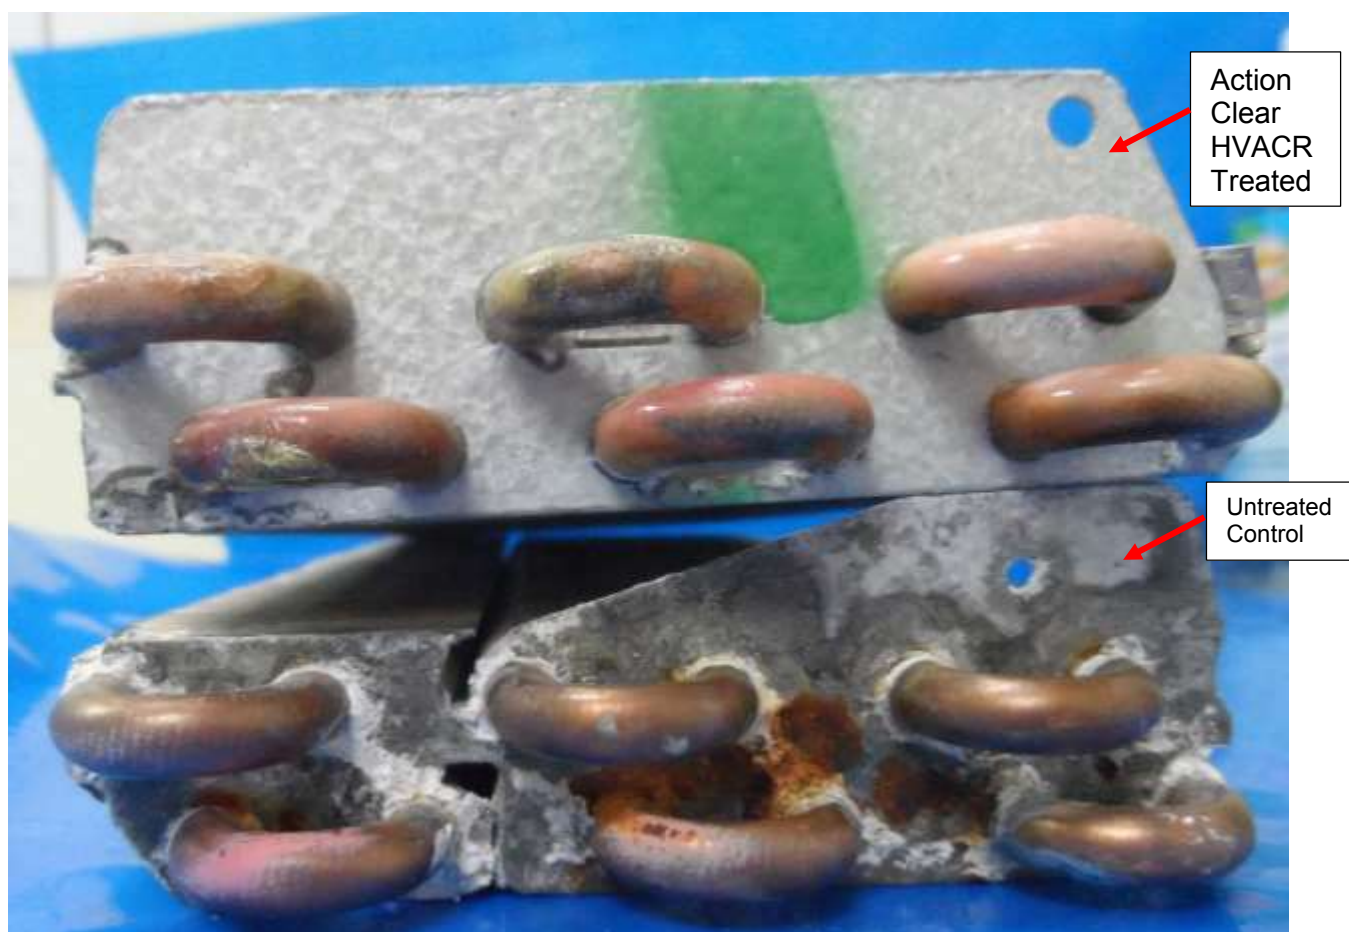
Fig 7: Action Clear HVACR Treated & Untreated Control samples after 168 hours neutral salt spray exposure, Comparison of end plates.

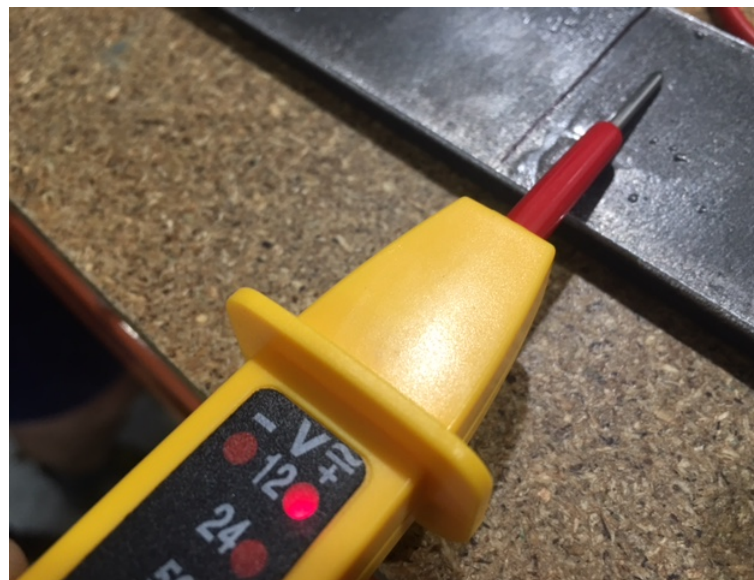
1) 3mm thick mild steel plate 65mm x 200mm. A third of the sample plate sprayed with two coats of Action Clear aerosol to achieve a (DFT) of 25 microns.

2) 3mm thick aluminium plate 50mm x 200mm. A third of the sample sprayed with two coats of Action Clear aerosol to achieve a (DFT) of 25 microns.

The image below indicates the aluminium plate on the left and mild steel on the right.

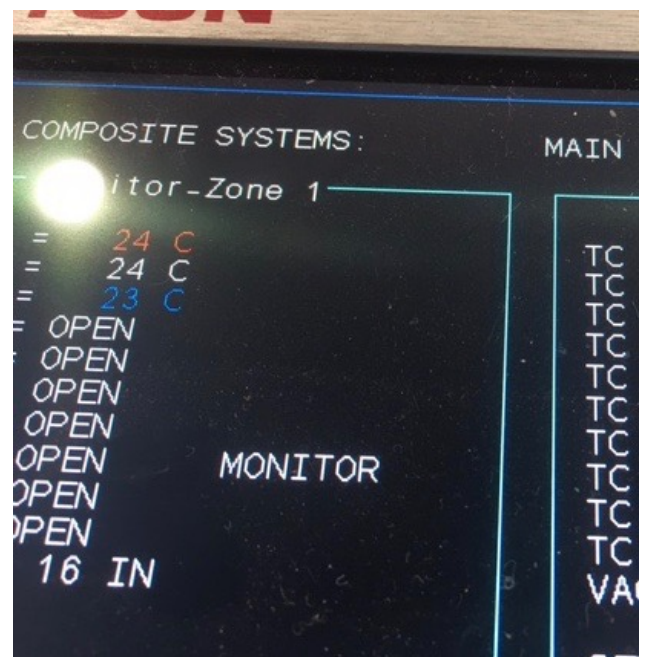
The two images below represent the variations in temperature collected by sensors in the three locations on the aluminium panel a minute after heat was applied.

Under higher temperatures, it was determined the most explanatory data would come from readings from sensor 1 and sensor 3, as they were at opposing ends of the sample plate and did not have heat directly applied to their area as per sensor 2. When the data from sensors 1 and 3 were compared on six temperature variables, on four occasions the readings were identical. On the other two occasions there was only a one degree celsius temperature difference.

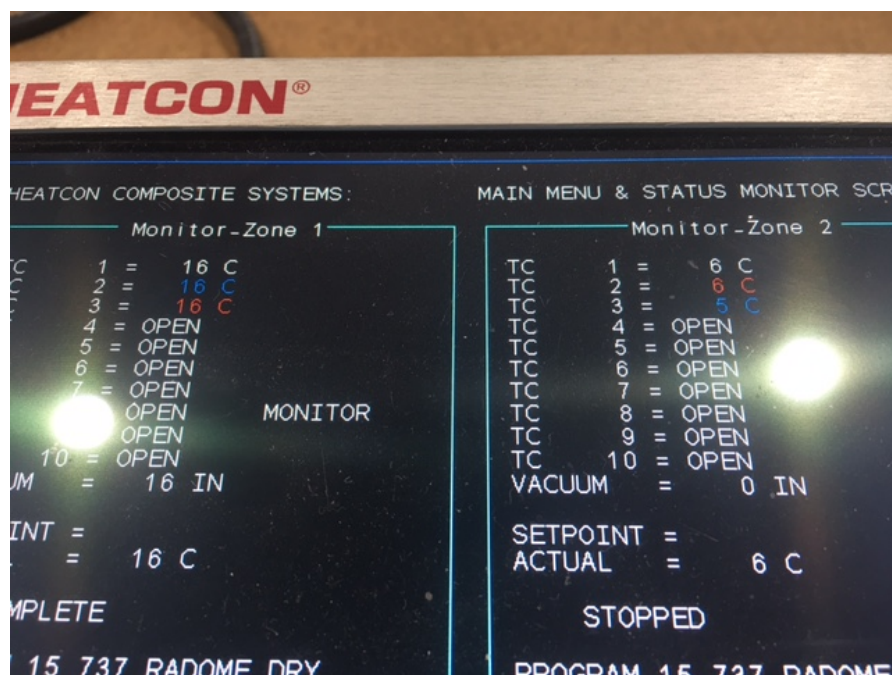
Heat exchange was next monitored on cooler temperatures. Both panels were placed in a freezer and sensors attached in the same three locations.

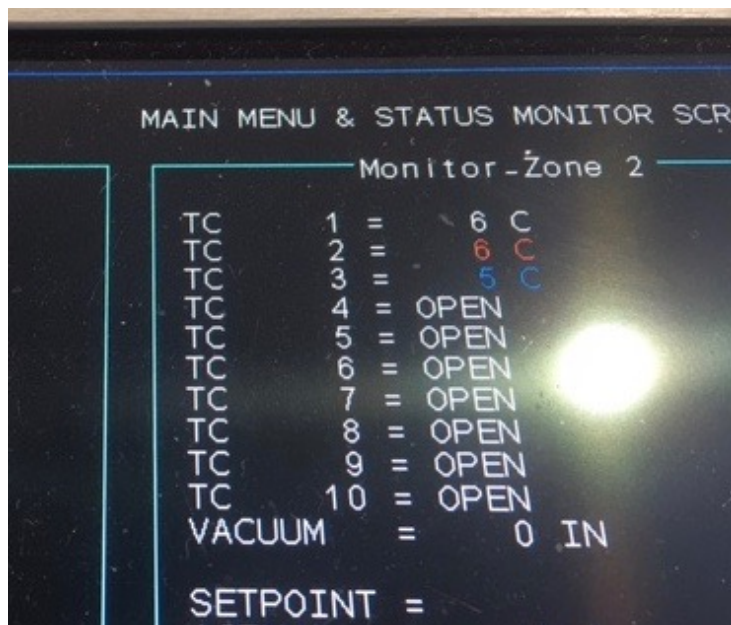
The mild steel panel when subjected to lower temperatures showed no noticeable temperature variation between the three sensor locations.
